# The Science of *Utilibond*™

## Adhesion and Cohesion

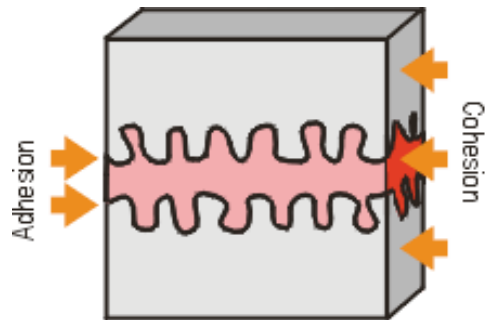
**Figure 1.** The types of forces in an adhesive joint.

**Cohesion:** Cured adhesives or bonding agents, like other materials, can also be characterized by their internal strength, or the force required to cause permanent deformation, i.e. to break the bond. To differentiate from adhesion, cohesive strength of adhesives and substrates is used for this internal strength as shown in *Figure 1*.

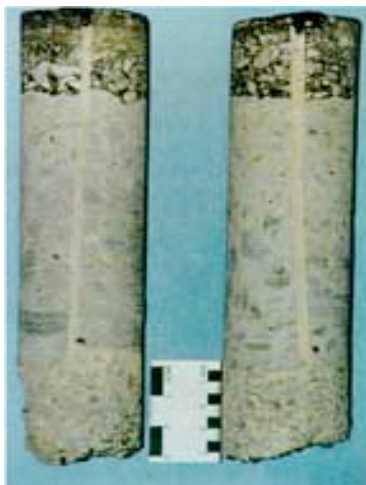
**Figure 2.** Satellite core samples taken through bonded area of reinstated core. The light gray line is *Utilibond* showing excellent bonding of asphalt-concrete core (central area) and undisturbed pavement (outer layer) with complete infilling of voids in pea gravel (bottom). (See: Golder Report).

To test the effectiveness of the bond, Golder cut satellite core samples through the kerf of previously reinstated cores

as shown in *Figure 2*. These samples showed perfect and complete bonding or adhesion of the *Utilibond* to both the surface of the core or coupon and the surface of the remaining pavement as well as excellent “cohesion” through the joint itself.

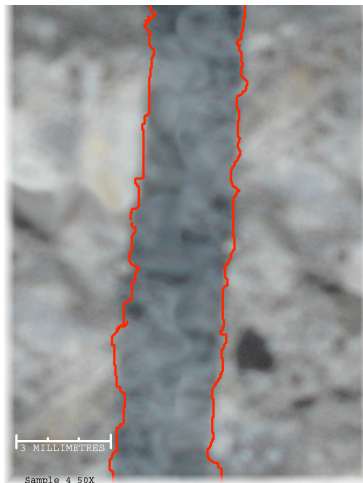
**Figure 3.** *Utilibond* microstructure (illustrated)

An examination of the microstructure of the interface between *Utilibond* and the concrete substrate of the core and the surrounding pavement shows a very strong and high quality adhesive and cohesive bond. (Figure 3.)

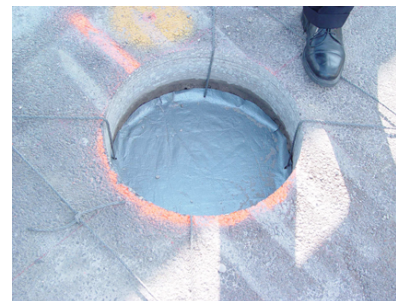
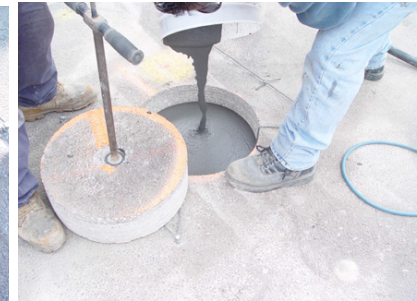
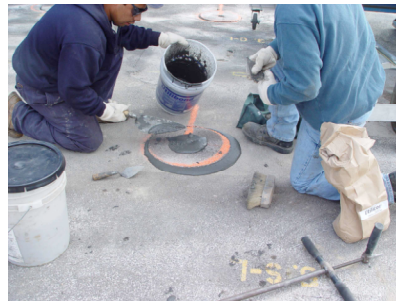
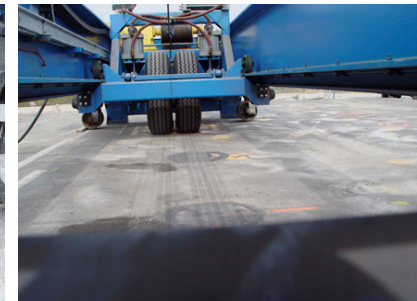
*False bottom hole*

*Utilibond poured into hole*

*Setting the core*

*Loading machine 40,000 + passes*

**Figure 4.** GTI “No Bottom” Core Test (Photos courtesy of GTI)

The original GTI study plan was to demonstrate the effectiveness of backfill compaction as a factor in keyhole reinstatement. They planned to use various levels of compaction — good — fair — poor and no backfill at all. They started with the *no backfill* experiment in which they cored and vacuumed an 8 inch deep hole in asphalt, inserted a temporary false bottom consisting of a cardboard plate suspended by strings on to which they placed pea gravel and then *Utilibond* and reinstated the core (See Figure 4). After the *Utilibond* set they released the string supports of the false bottom and began testing the ability of the *Utilibond* to support a suspended core — with no backfill under it.

To do this they passed their 9,000 lb AASHTO standard test vehicle over the core and to their surprise it sustained **more than 40,000 passes** before giving way and settling about 20 millimeters on one side.

As some of the failure appears to have occurred in the asphalt outside the bond and the *Utilibond* layer in that area remained intact, the technicians were unable to determine whether or not it was failure of the asphalt around the core that occurred first, there being no bridging strength in asphalt, causing undue torque on the core that then caused the failure in the bond, or whether it was failure of some areas of the kerf that may not have been fully impregnated with bonding agent when the core was originally set into the hole. For obvious reasons, when reinserting the core, the technicians were reluctant to aggressively manipulate the core (as would have been done to distribute the *Utilibond* in a normal reinstatement) for fear of destroying the false bottom.
