New Orleans, Louisiana  
March 22-24, 2004

## HEALING THE UTILITY CUT: A UNIQUE CORING AND PAVEMENT RESTORATION PROCESS

E. Marshall Pollock, President & CEO, Utilicor Technologies Inc., Toronto, ON, Canada

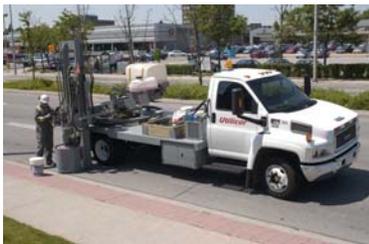
**Figure 1.** *The Utilicor coring unit operates through a complete 270° arc, allowing the truck to be positioned on the shoulder or off the traveled surface to minimize traffic disruption.*

The technology, as shown in Figure 1, involves a very robust, purpose-built, rotary cutting unit that works through a complete 270° arc (patent pending) that quickly and cost-effectively cores an 18” diameter hole through asphalt, asphalt-concrete and reinforced concrete road systems and sidewalks to enable crews to vacuum excavate, and view subsurface activity or repair underground plant from the road surface

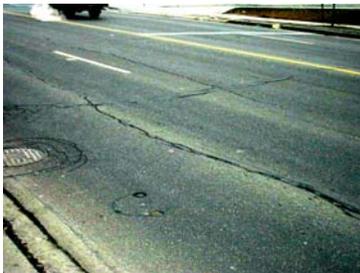
**Figure 5.** *Pavement core reinstated in bus lane with Utilibond in 1995 still in perfect condition seven years later in 2002.*

Several of these sites, including one originally excavated and reinstated in August 1995 (Figure 5), have been regularly monitored and found to be without any apparent weakening or degradation of the reinstated core or adjacent road system or paved surface, notwithstanding the fact that in the intervening eight year period more than 145,000 transit buses and more than 13 million commercial and other vehicles have passed directly over the repaired keyhole.

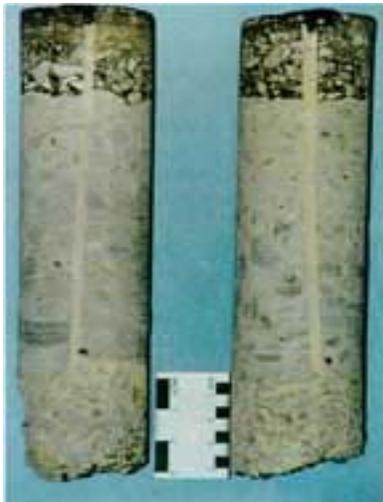
**Figure 6.** *Satellite core samples taken through bonded area of reinstated core show effective coupling.*

Core samples taken at the site (Figure 6) demonstrate effective coupling between the core and the remaining slab of pavement. Light gray line is Utilibond showing excellent bonding of asphalt-concrete core (central area) and undisturbed pavement (outer layer) with complete infilling of voids in pea gravel (bottom).
